FISCALINI RANCH PRESERVE

CAMBRIA, CALIFORNIA

2020 CONSERVATION EASEMENT MONITORING REPORT

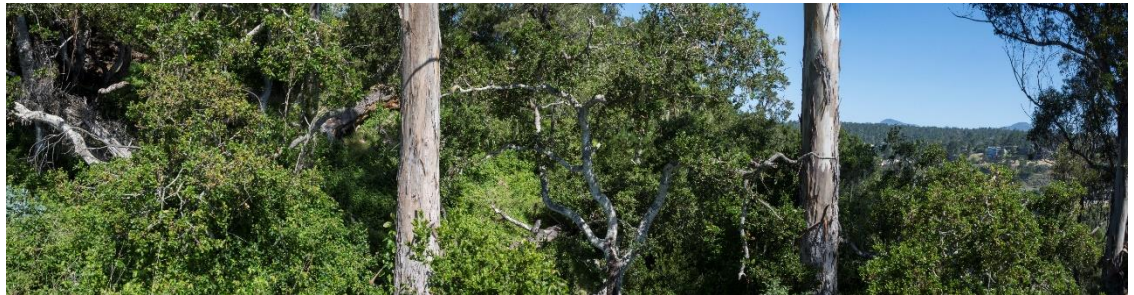
4b

2020 Comments: Eucalyptus saplings were removed.

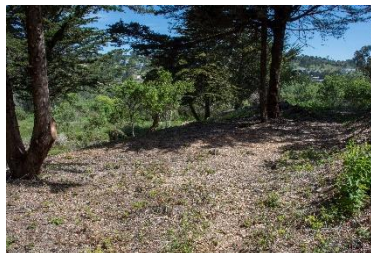
6

2020 Comments: Dramatic clearing of the site: 30' long homeless encampment removed.

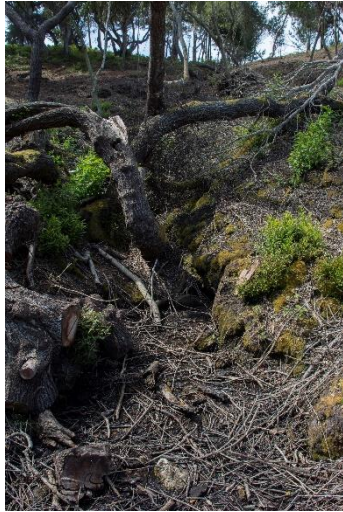
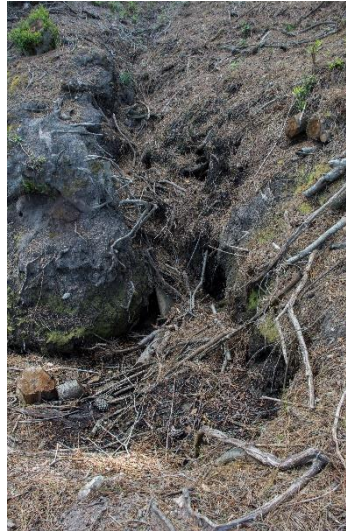
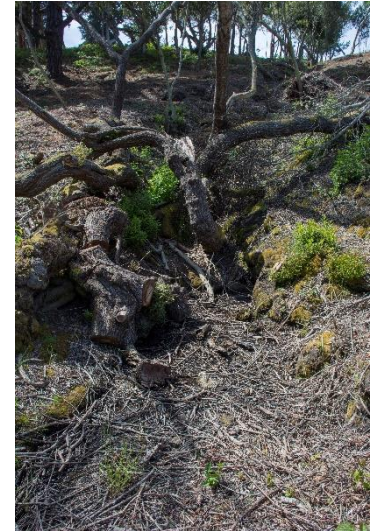
8

2020 Comments: Dramatic clearing, site now accessible, significant regeneration of eucalyptus seedlings along border, nonnatives taking over understory.

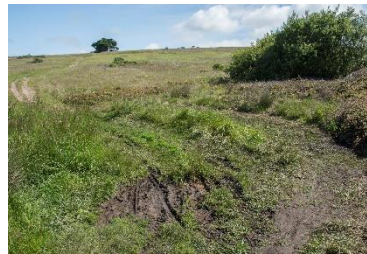
16

2020 Comments: The Dolphin Trail was widened to allow for social distancing. It was still wet in April with standing water in some places. It needs an elevated path to protect the crossing.

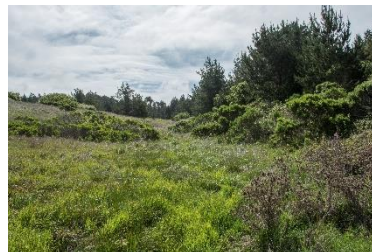
18

2020 Comments: The trail running parallel to the gully is almost gone. New pines and small coast live oaks are filling in here. The gully head is disappearing.

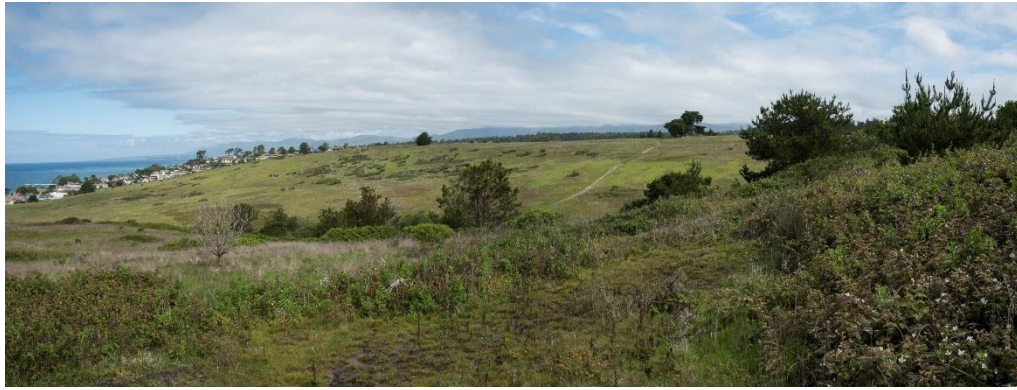
20

2020 Comments: Quite wet with water at surface and saturated soi.

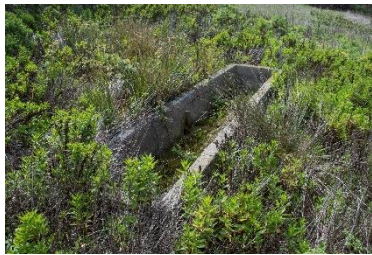
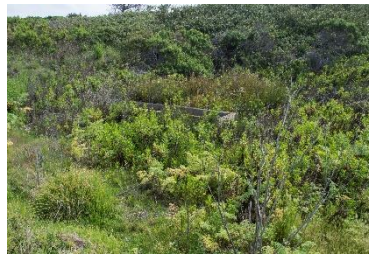
22

2020 Comments: Poison hemlock and thistles continue to fill in.

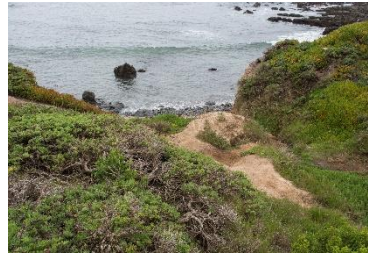
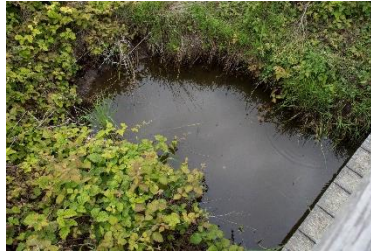
27

2020 Comments: More California blackberry around bridge. Stepped swale is slowing erosion.

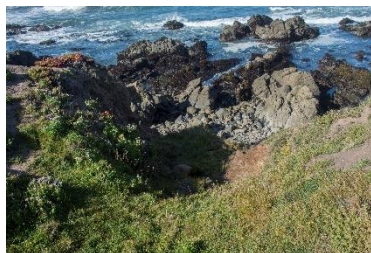
28

2020 Comments: Erosion starts at 3'9" from trail (4'10" in 2019, 6'6" in 2017).

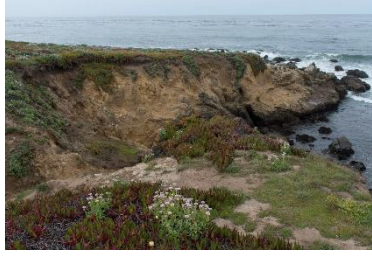
29a

2020 Comments: Trail is less than 14' from bluff edge. Rare and endangered compact cobwebby thistle near trail.

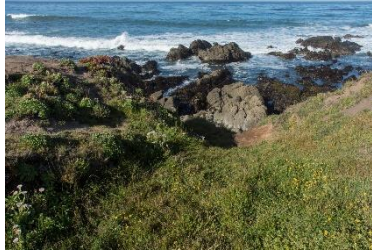
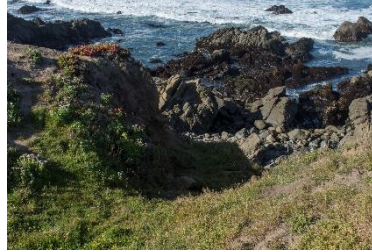
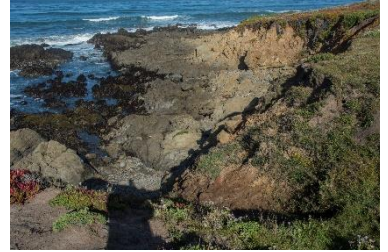
29b

2020 Comments: Successful removal of ice plant. Native returning.

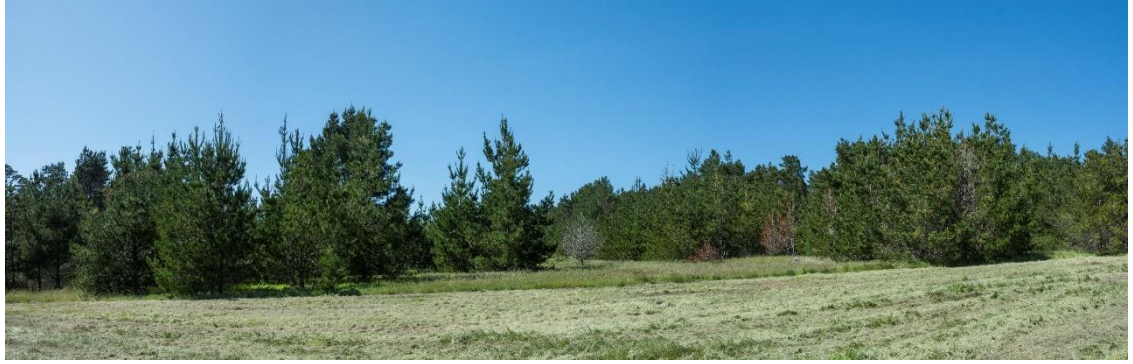
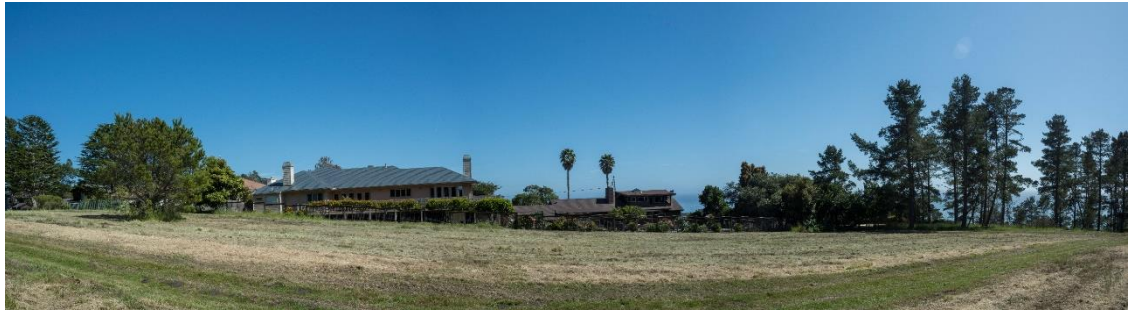
36

2020 Comments: Area of extensive Western gall rush infestation and mortality. Infected limbs removed in 2019. Hazardous trees removed.

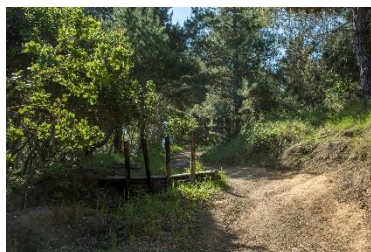
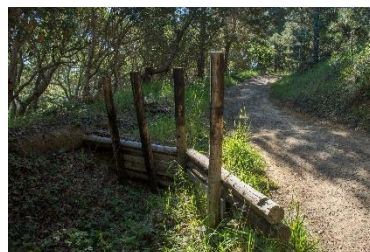
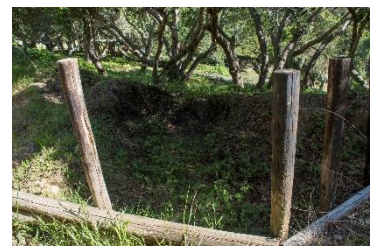
43

Drainage from uphill side of trail causing erosion, deep in places.

2019 Comments: Trail much improved by red rock that was added in 2019 and 2020 plus drainage outflows added by FFRP volunteers.

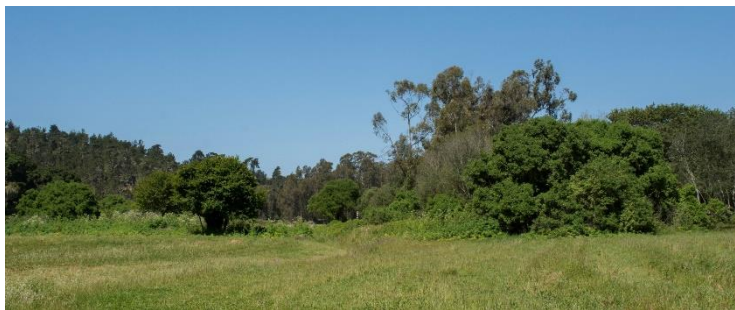
46

2020 Comments: Broom removal in fall 2019. Island full of native stinging nettle, coffee berry, and blue elderberry, as well as invasive French broom and poison hemlock.

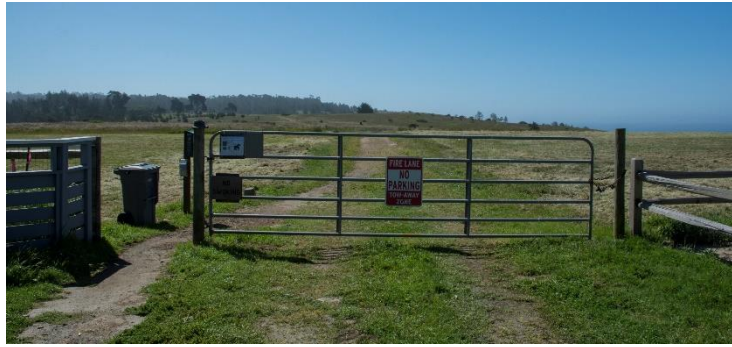
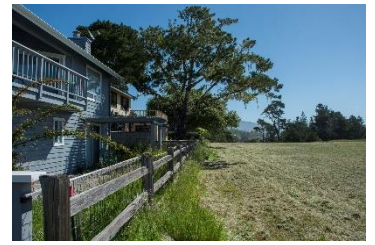
Huntington Street / Park Hill Ridge Trail Entrance

2020 Comments: Pedestrian entrance has been moved to right side and encroachment resolved since photo.

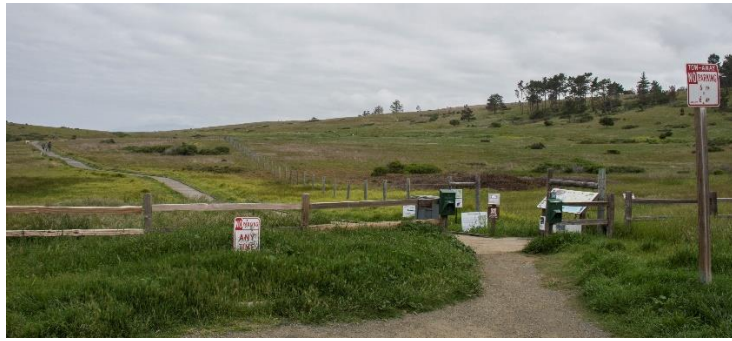
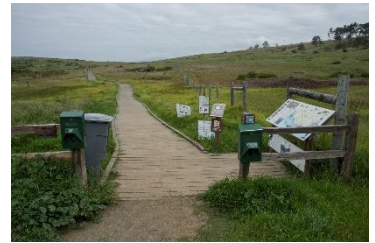
Bluff Trail South / Marine Terrace Entrance

2020 Comments: Fencing replaced. Temporary signage due to covid-19 restrictions.

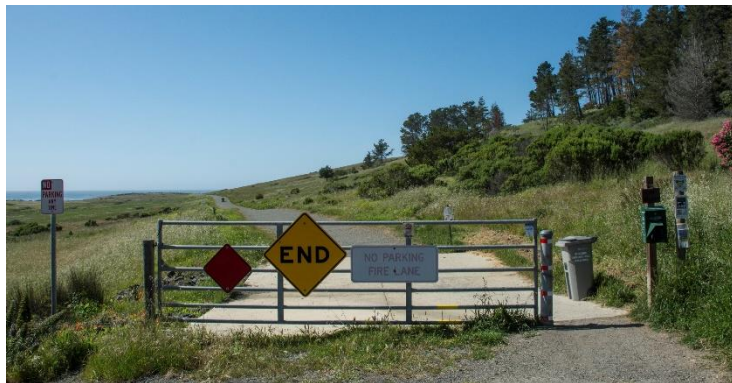
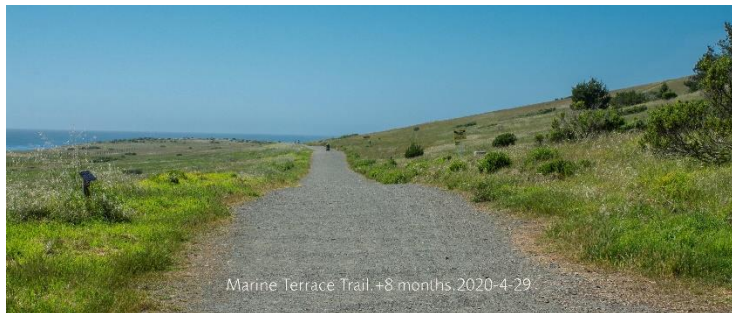
Marlborough Street Entrance

2019 Comments: Drainage and erosion unchanged. Forest retreating in this area. Construction activity had encroached on Ranch several times. CCSD contacted owner for remedy and house completed in January 2020.
