FISCALINI RANCH PRESERVE

CAMBRIA, CALIFORNIA

2020 CONSERVATION EASEMENT MONITORING REPORT

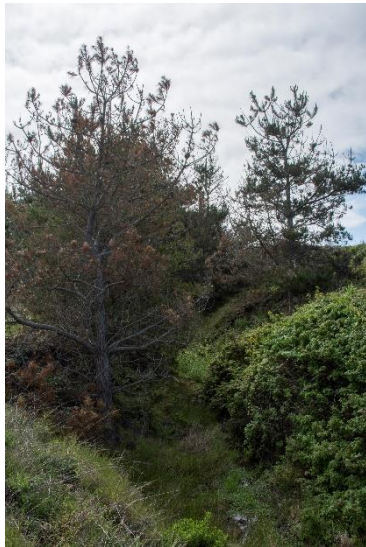
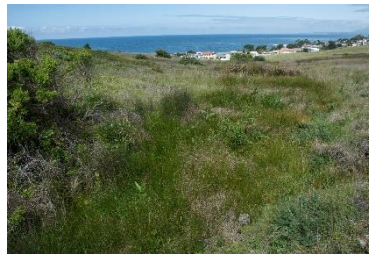
26

2020 Comments: Well vegetated with poison oak, California blackberry, rush, wild rye, monkey flower, and various invasive thistles.

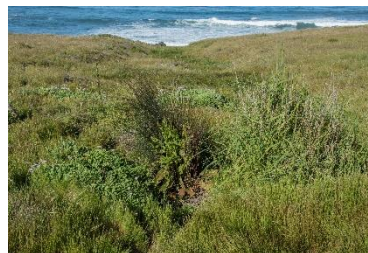
29

2020 Comments: Erosion starts at 3'9" from trail (4'10" in 2019, 6'6" in 2017).

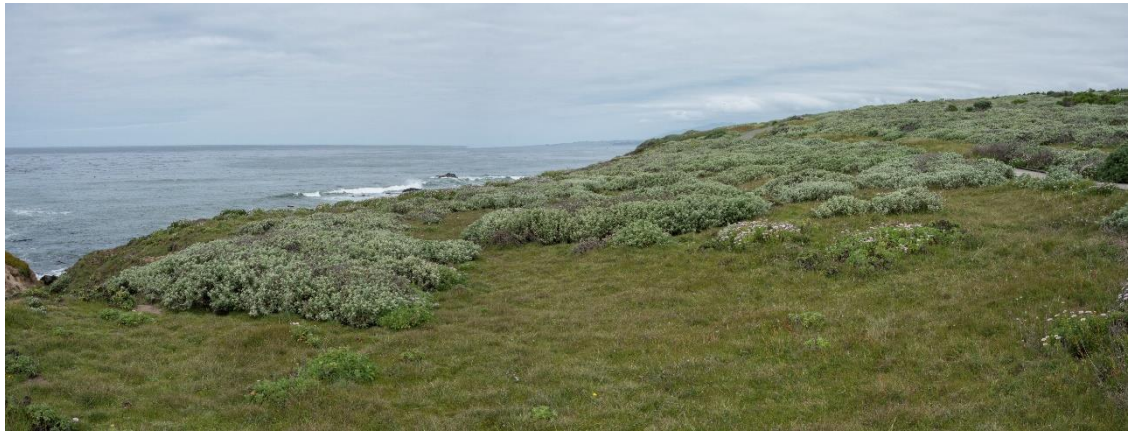
30

2020 Comments: Successful removal of ice plant. Native returning.

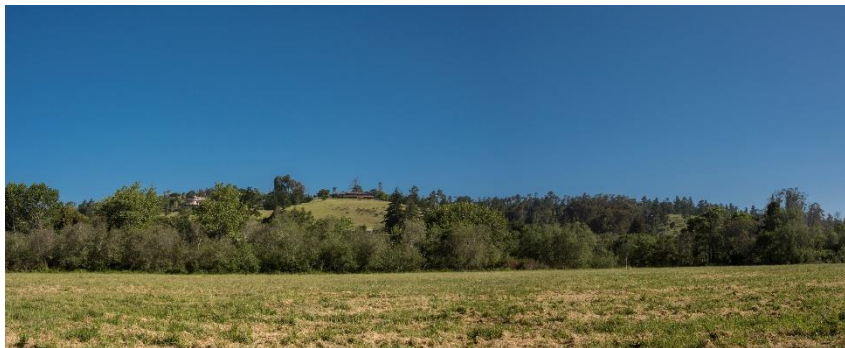
46

2020 Comments: Mowed three times a year.

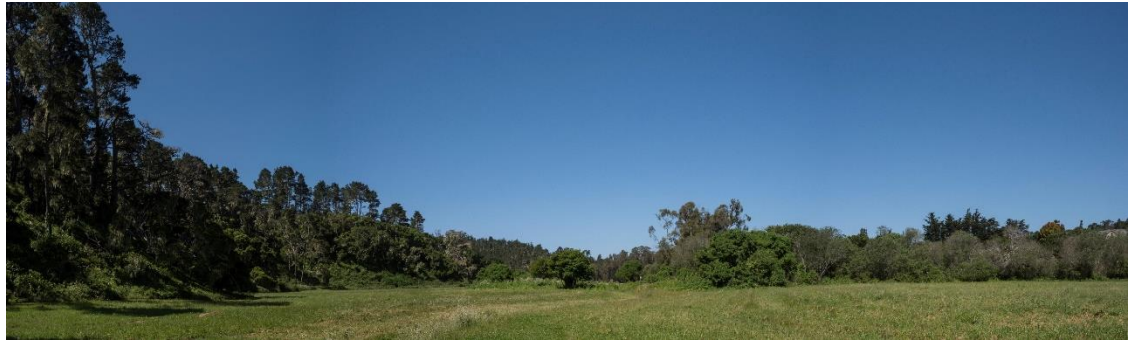
47

2020 Comments: Broom removal in fall 2019. Island full of native stinging nettle, coffee berry, and blue elderberry, as well as invasive French broom and poison hemlock.

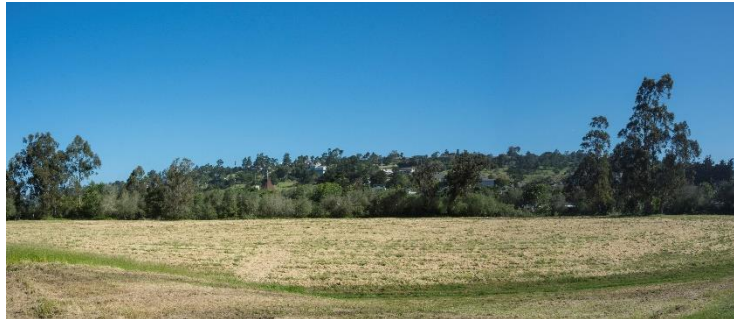
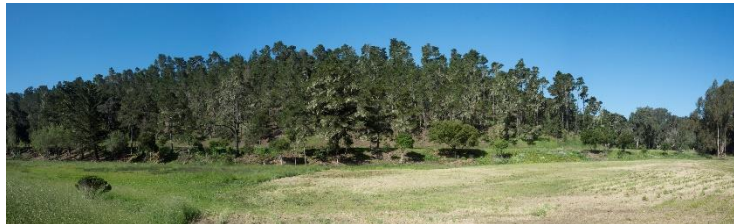
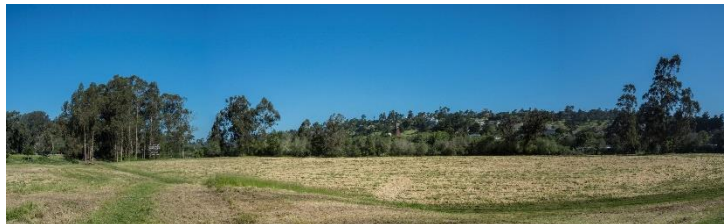
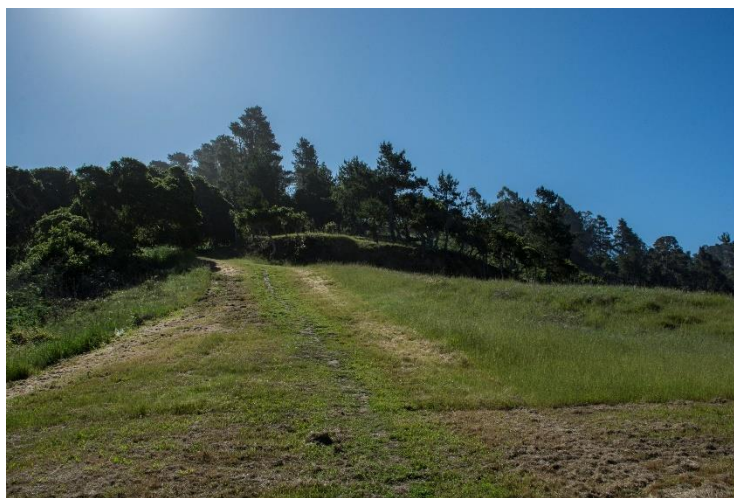
49

2020 Comments: French broom removal in 2019. Trees pruned.

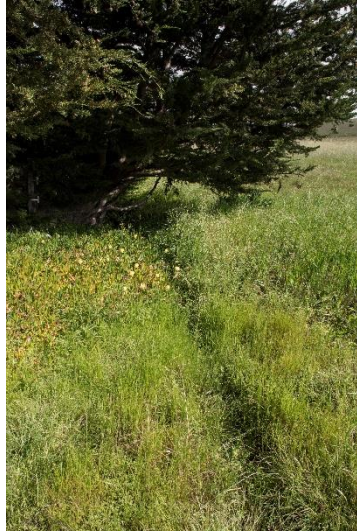
2020 Comments: Overgrown.

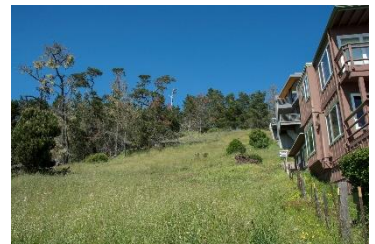
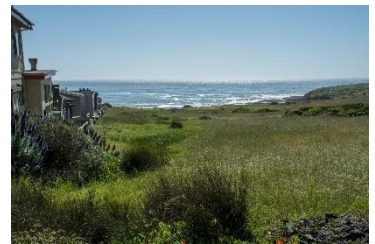
Marlborough Street Entrance

2019 Comments: Drainage and erosion unchanged. Forest retreating in this area. Construction activity had encroached on Ranch several times. CCSD contacted owner for remedy and house completed in January 2020.

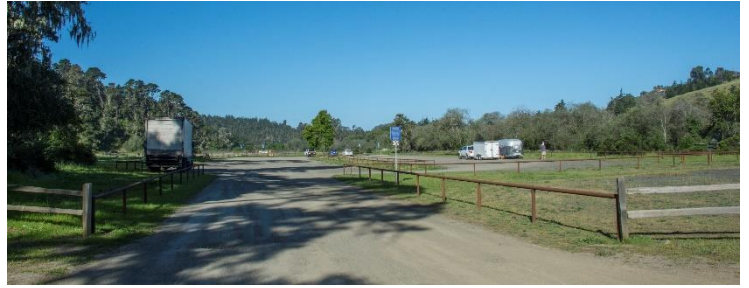
**Rodeo Grounds Entrance
at East Ranch**

2020 Comments: Little change.

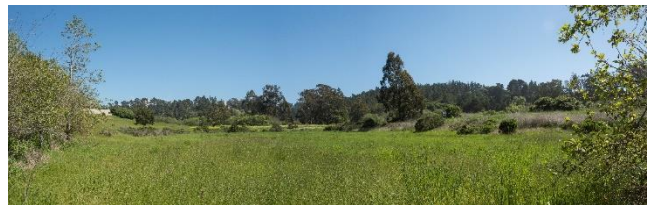
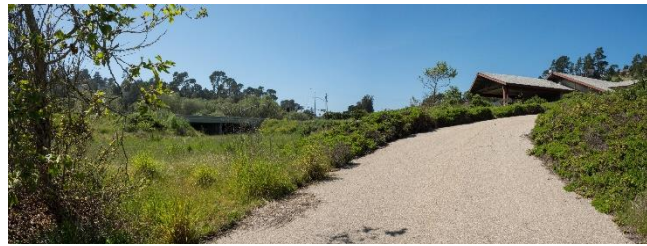
M1

Mid-State Area

Flat at end of driveway from Mid-State parking lot.

2020 Comments: Little change.
